**Air Leakage Test Results for St Nicholas Court (Fieldside Place)
Development, York**

Jez Wingfield, Centre for the Built Environment, Leeds Metropolitan University

Report prepared by		
Name: Jez Wingfield, David Johnston		
Organisation: Centre for the Built Environment. Leeds Metropolitan University. Brunswick Terrace. Leeds LS2 8BU		
Project manager:		
Signature		
Date: 29 April 2004

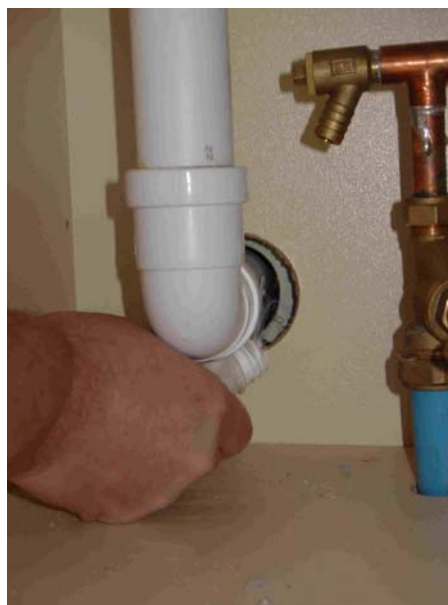
- a) Service penetrations in kitchen (except plot 4)

Figure 13 - Leak around Sink Outlet Pipe Penetration (Plot 16 kitchen)

- d) Lack of site supervision and quality control.
 - e) No apparent remedial action taken after first set of air leakage tests.
22. In general, there is poor attention to sealing of pipe penetrations. These should be sealed with the use of an appropriate expanding foam or sealant. There are also some significant leaks around door frames and windows (especially Velux) which should be rectified by adjustment, component replacement or sealing. The gap between skirting boards and floor should also be sealed with an appropriate sealant. A sealing strip should be used on the loft hatch and mechanical clips fitted that pull the hatch down onto the seals.

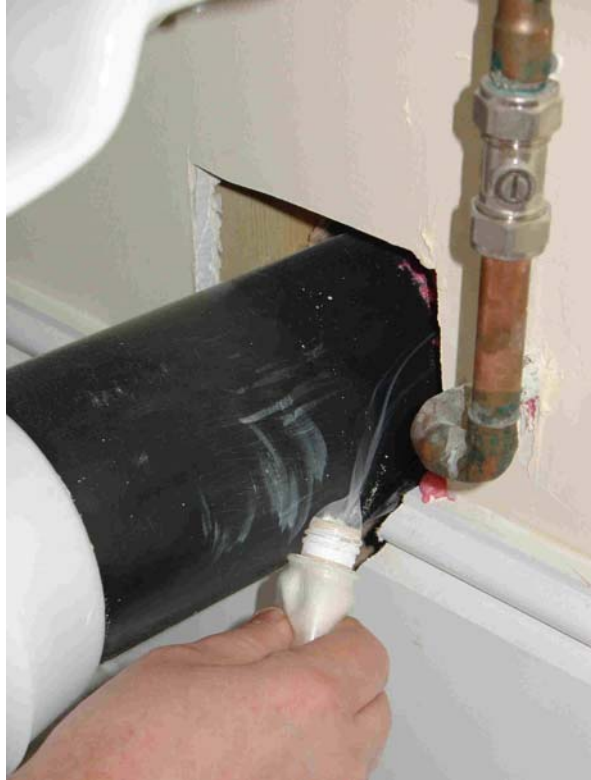
b) Service penetrations in downstairs toilet

Figure 14 - Leak around Soil Pipe Penetration in Downstairs Toilet (Plot 17)

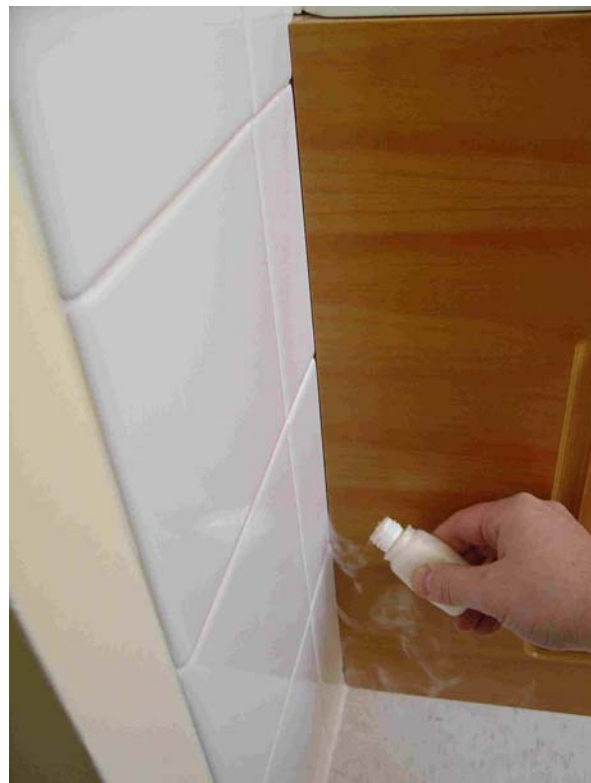
c) Service penetrations in bathroom and around bath panel

Figure 15 - Leak around Bath Panel (Plot 16)

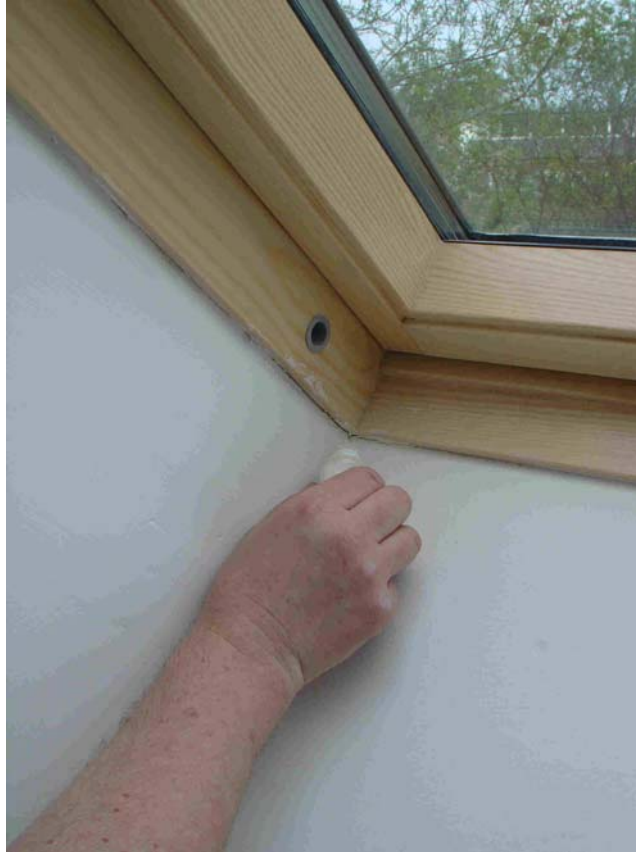
d) Joint between Velux window frame and wall

Figure 16 - Leak at Gap between Velux Frame and Wall (Plot 4)

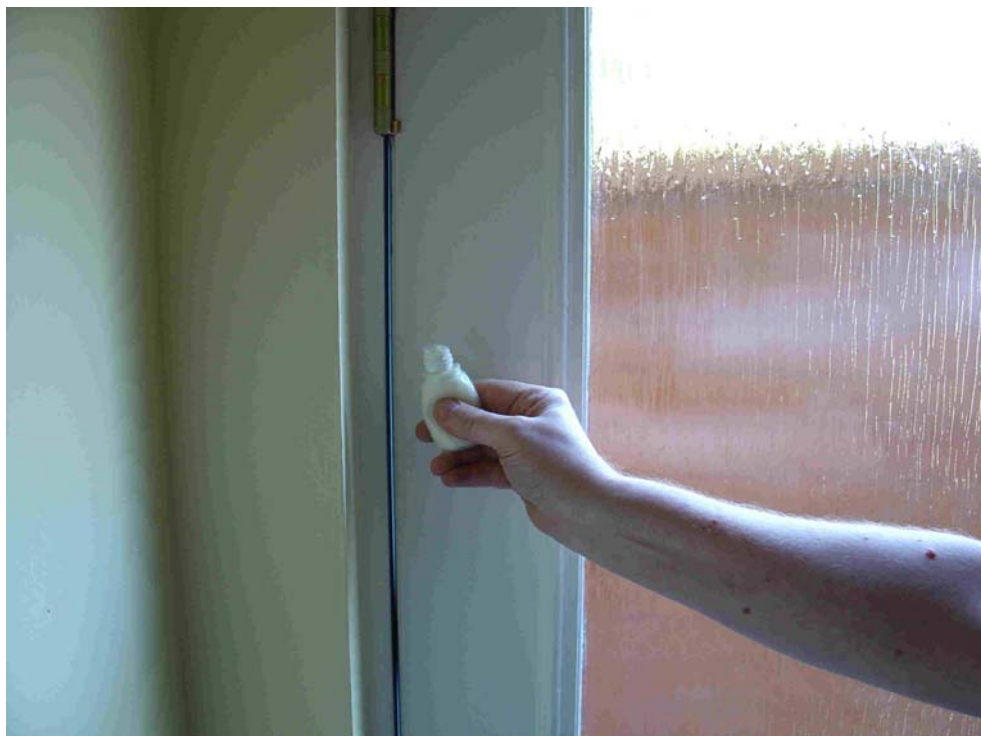
e) Gap between back door and door frame

Figure 17 - Leak around Back Door Frame with Smoke Shown Flowing Outside (Plot 16)

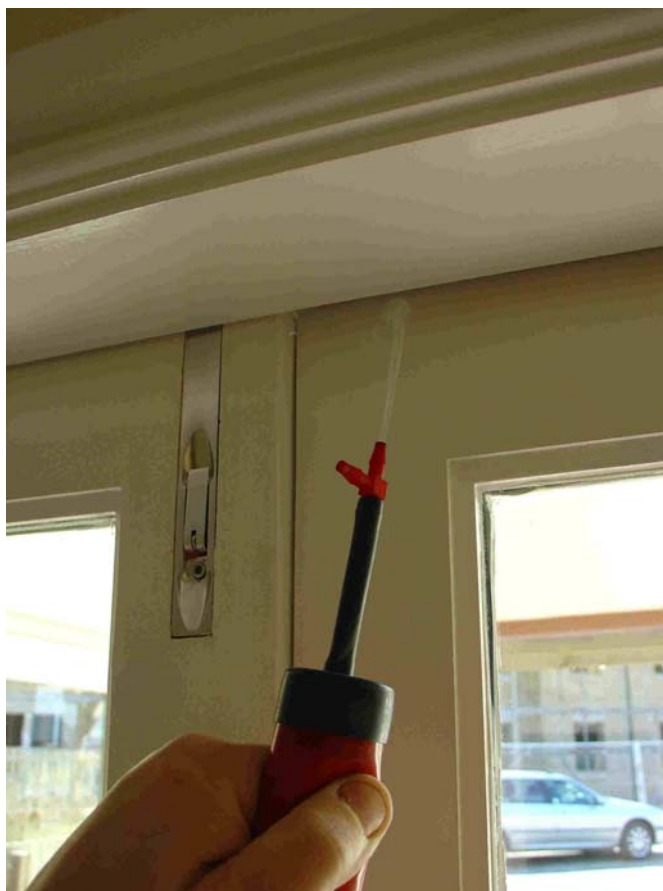
- f) Gap between sun-space doors and frame (doors warped)

Figure 18 - Leak at Warped Sun-space Doors (Plot 16)

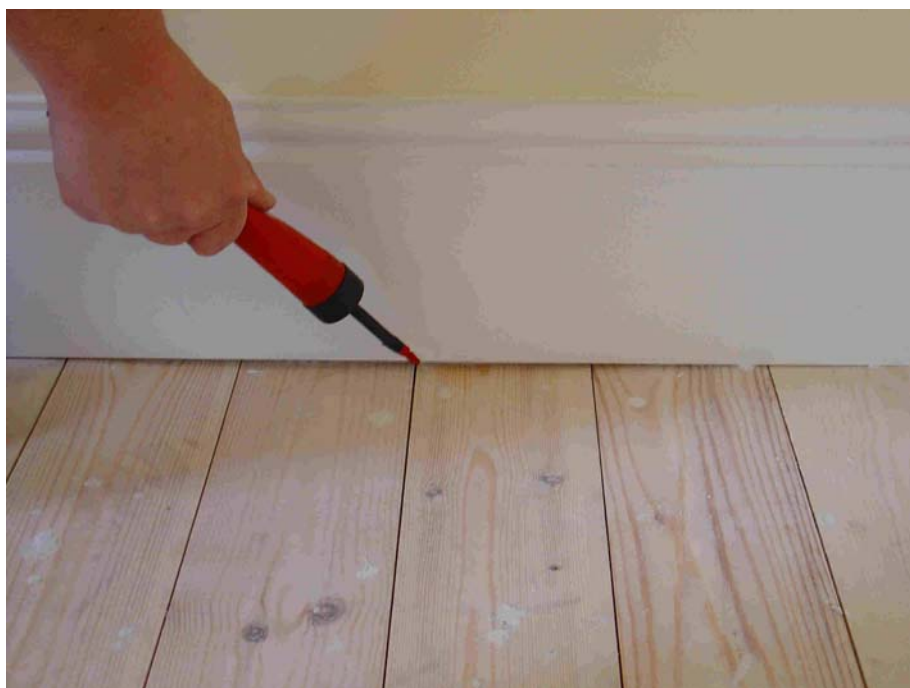
- g) Gap between skirting board and floor

Figure 19 - Leak at Gap between Skirting Board & Floor (Plot 4)

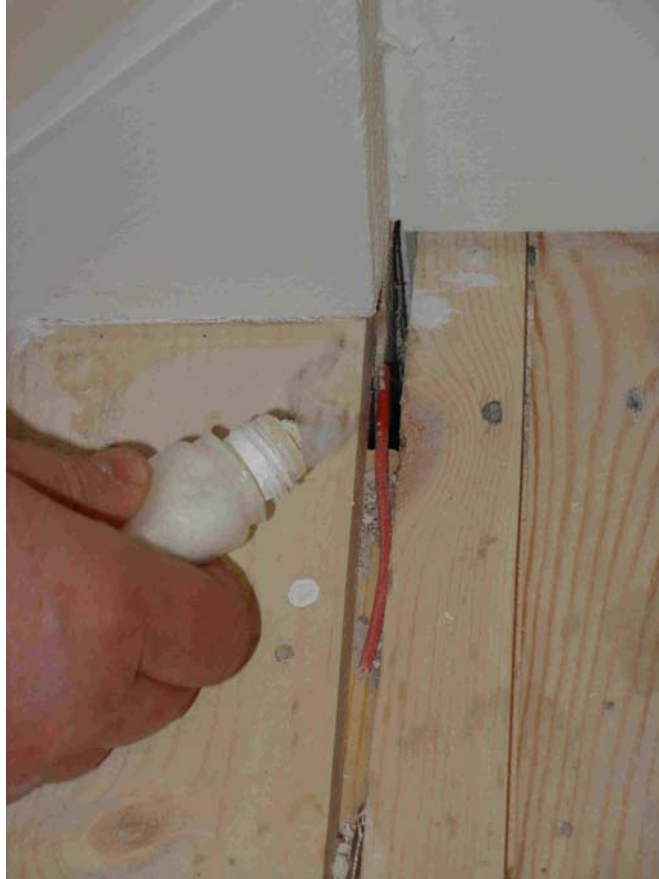
h) Gaps in flooring

Figure 20 - Leak at Gap in Flooring (Plot 4)

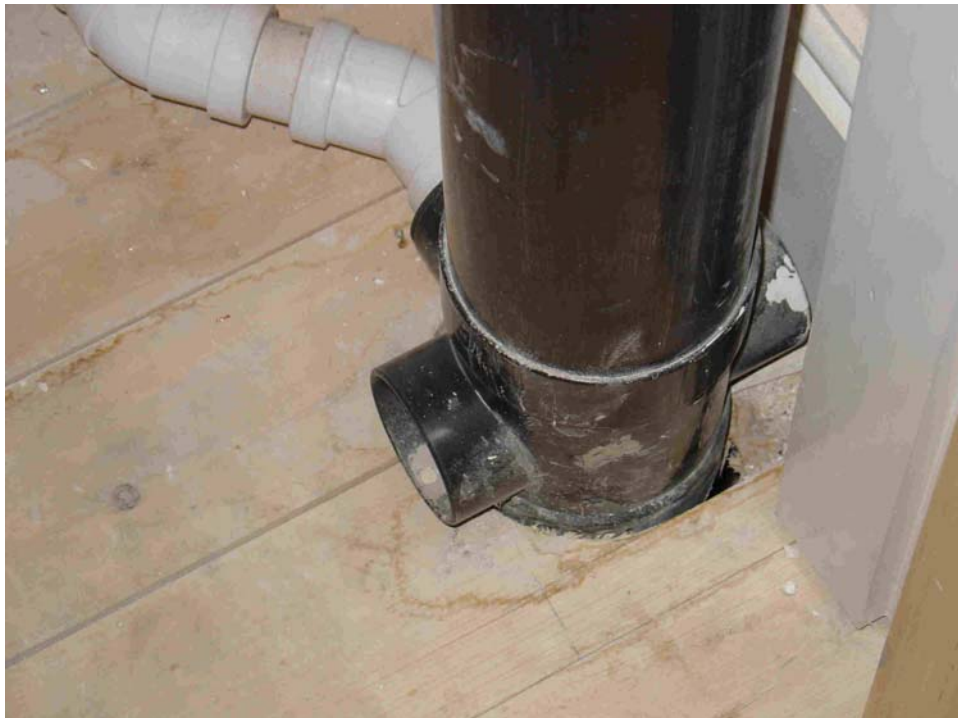
i) Around soil vent pipe in boiler cupboard (into floor and into attic)

Figure 21 - Gap around Soil Vent Pipe in Floor of Boiler Cupboard (Plot 17)

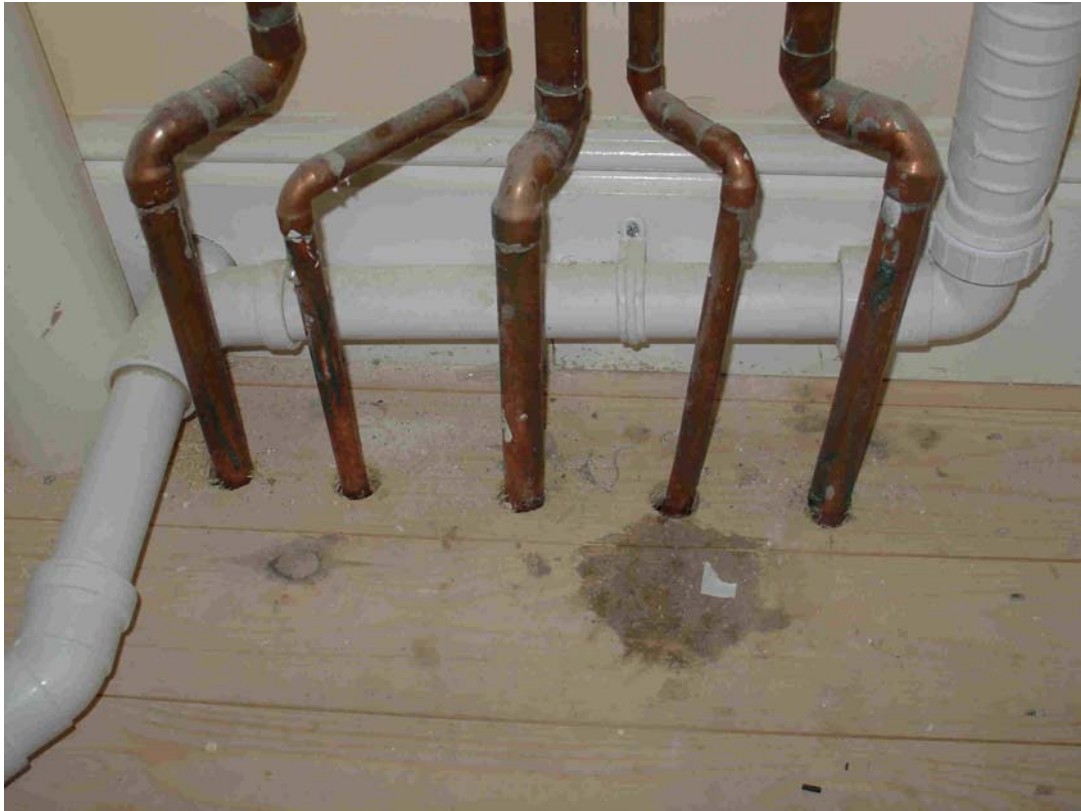
j) Through unsealed water pipe penetrations in boiler cupboard

Figure 22 - Unsealed Pipe Penetrations in Boiler Cupboard (Plot 16)

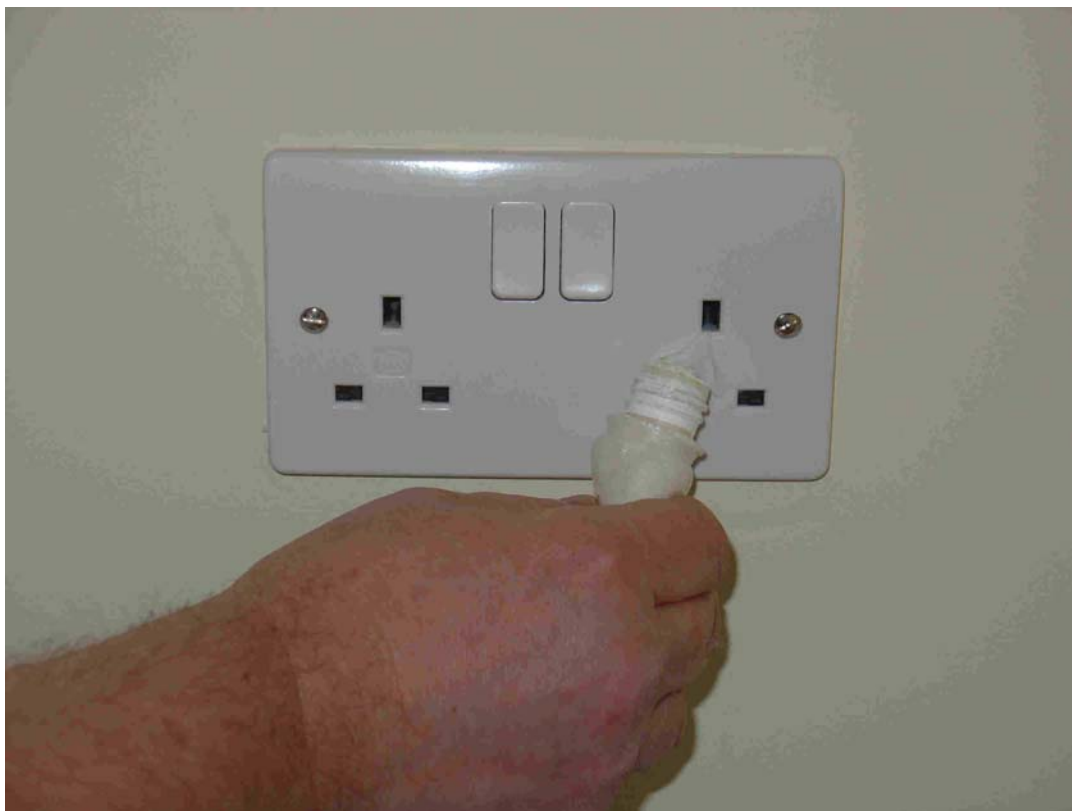
k) Through electrical sockets and cable outlets

Figure 23 - Leak through Electrical Socket (Plot 18)

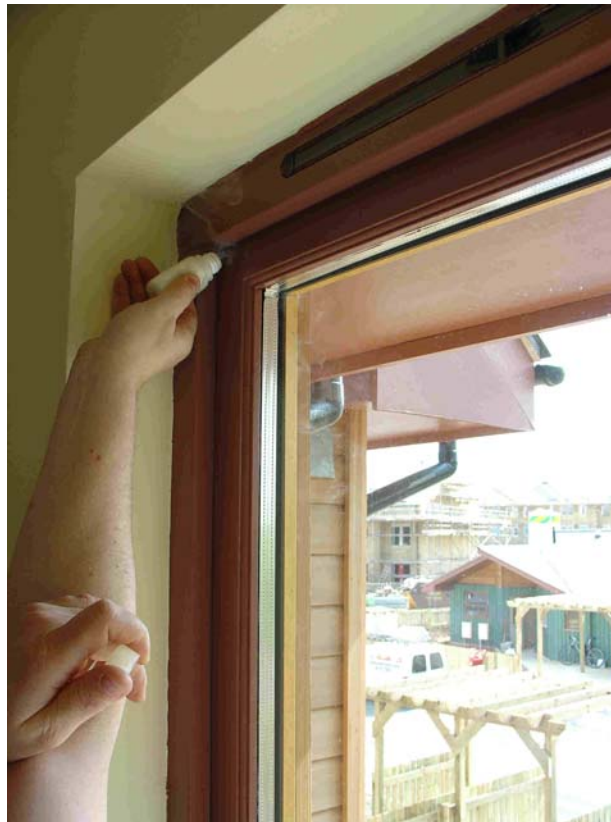
m) Between frame and window of bedroom window in plot 4

Figure 25 - Leak around Window Frame in Bedroom with Smoke Flowing Outside (Plot 4)

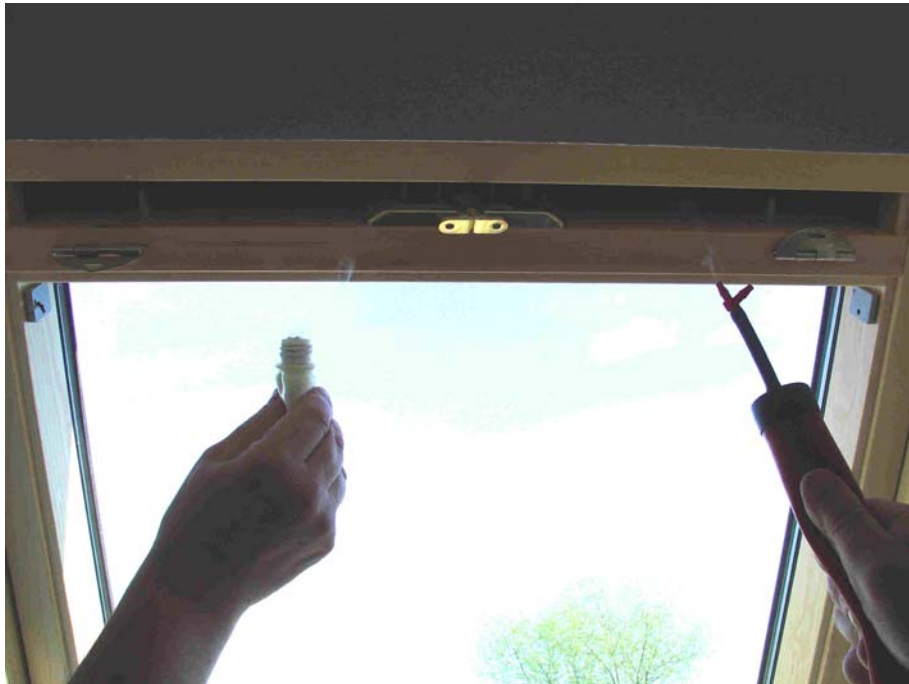
n) Missing trickle vent in Velux window in dwelling 17

Figure 26 - Leak through Missing Velux Trickle Vent/Handle (Plot 17)

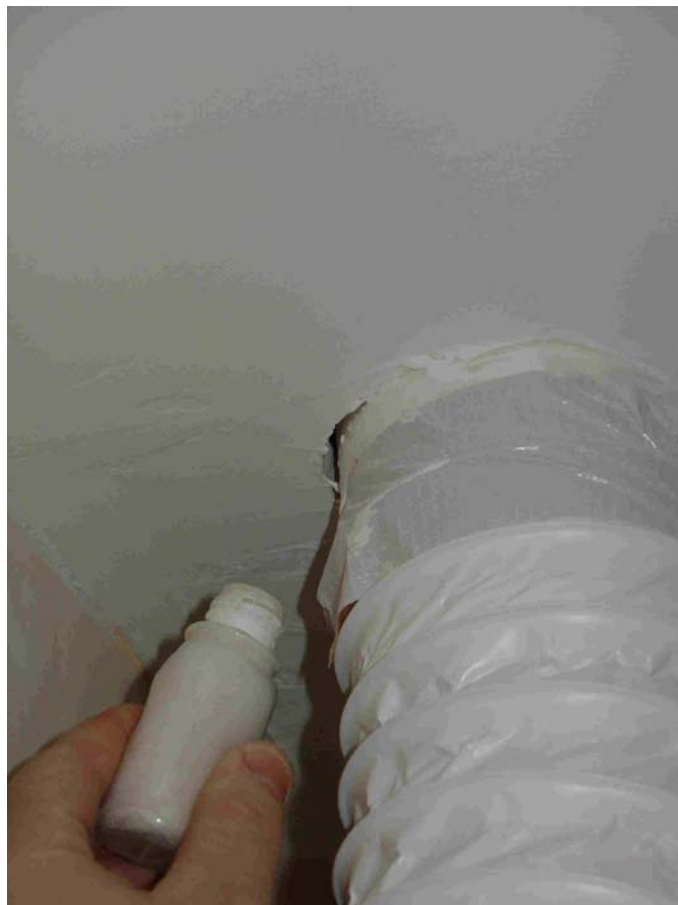
o) Gap in mechanical ventilation system pipe work penetration in ceiling

Figure 27 - Leak around Mechanical Ventilation System Pipe Work (Plot 18)

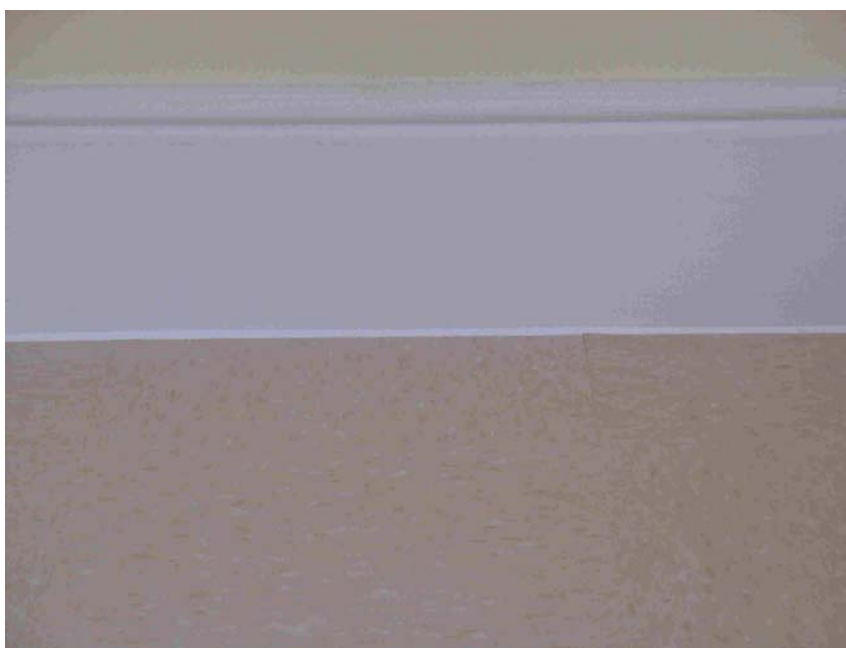
19. Many of the leakage paths had been identified in the previous test (Borland 2004) and have clearly not been remedied. Some attempts were visible in plot 4 (previously untested) to seal some of the problem areas. For example, expanding polyurethane foam had been used to seal around the service penetrations in the kitchen (Figure 28) and sealant had been used to seal the gap between skirting board and floor in the kitchen and downstairs toilet (Figure 29). These factors probably contributed to unit 4 having the lowest air permeability of the dwellings tested.

Figure 29 - Sealant used between Skirting and Floor in Kitchen of Unit 4
