Report to EURISOL

Investigations of the Party Wall Thermal Bypass in Timber Frame Dwellings

Final Report

June 2010

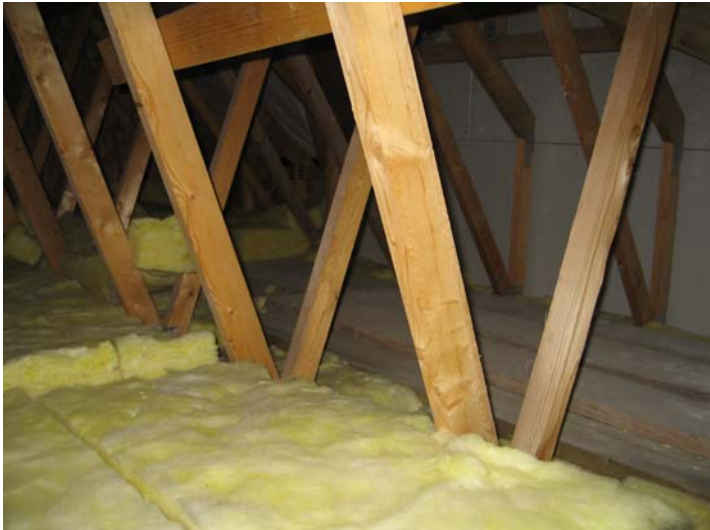
Figure 6 – Loft in House No.15 as Found

8 Prior to commencement of testing, the dwellings were surveyed for any construction issues that might affect the testing processes and also to check consistency with the as-built design drawings. The first issue identified was the condition of the loft insulation. There were found to be large areas of missing loft insulation, especially adjacent to the party wall as illustrated by the photographs of the loft in House No.15 (Figure 6) and in House No.16 (Figure 7). The presence of boarding in the loft indicates that the insulation was left out to enable work to take place on the party wall, but was not put back later. The developer was asked to remove the boarding and replace the loft insulation.

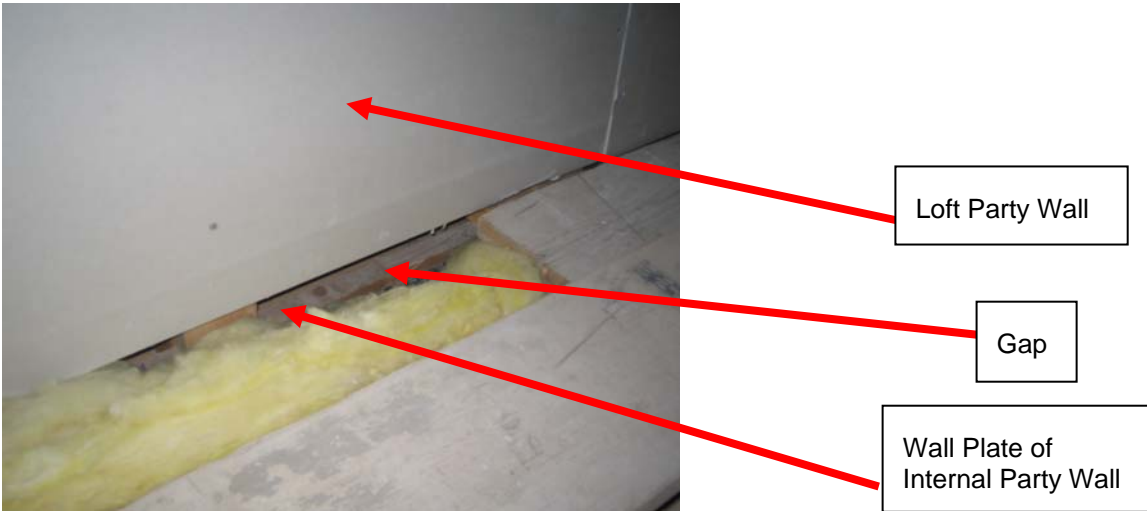
Figure 8 – Gap between Top of Internal Party Wall and Party Wall in Loft

9 A gap was observed between the wall plate at the top on the internal party wall and the loft party wall. This gap continued across the whole width of the party wall on both sides. The drawings for the junction in both E-WT-1 and E-WT-2 Robust Details show the party wall as being continuous up to the roof line with no gap (see Figure 9). It was not possible to do anything to change this detail in the two test dwellings, so the gap remained as found for the duration of the testing.

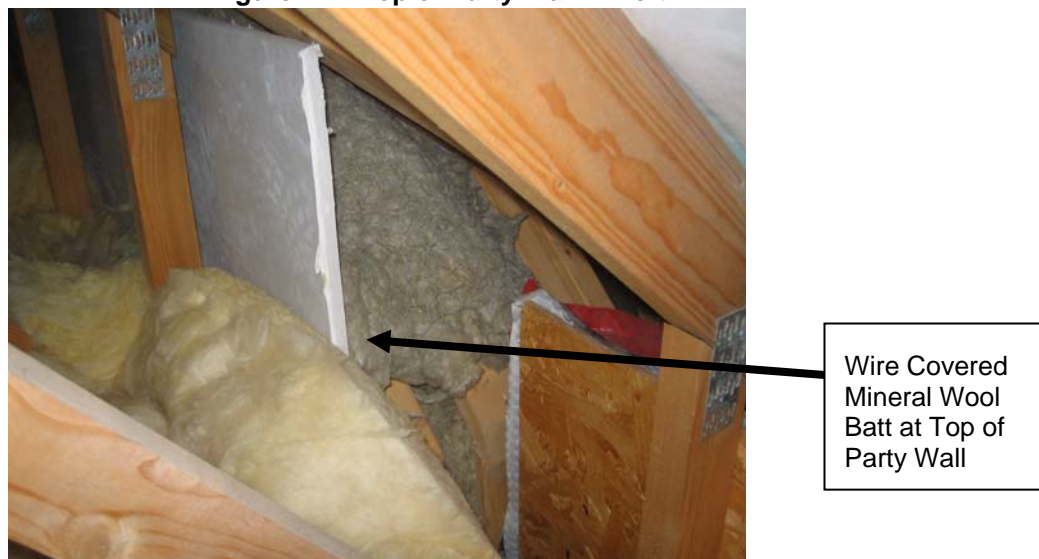
Figure 12 – Top of Party Wall in Loft

- 12 The top of the party wall in the loft at the junction with the roof had been fitted with a mineral wool batt restrained in a wire mesh, as shown in Figure 12. The same wire mesh/mineral wool batt had also been used in the inner cavity of the party wall in the loft, although this does not appear to be a requirement of Robust Details.

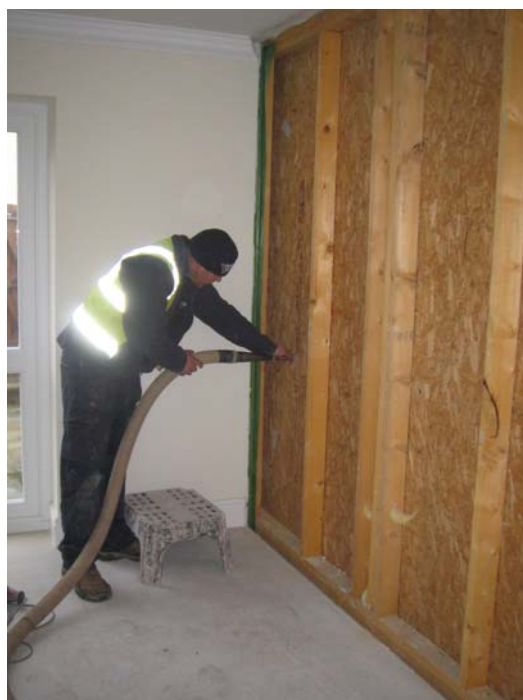
Figure 14 – Cavity Wall Technician Filling Party Wall at Darlington

- 18 Filling of the party wall cavity was achieved by drilling holes through the OSB. The pattern of the holes was set initially at a spacing that would be normal for a conventional masonry wall. However, the installation technicians had difficulty maintaining consistent flow. They believed that this was partly due to the variable cavity depth and possibly due to the difference in wall friction of the OSB compared to masonry. To alleviate this problem the technicians drilled additional holes and also adjusted the insulation injection settings. The fill density was nominally set at 20 kg/m^3 for the initial settings. The installers used $2 \frac{1}{2}$ bags of insulation, with each bag containing 17.6 kg , giving a total of 44 kg of insulation. The area of the party wall is 25.8 m^2 , plus approximately 5 m^2 for the area due to the terrace step, giving a total fill area of 30.8 m^2 . With a nominal 50 mm cavity width, the volume of the party wall cavity filled with insulation would be 1.54 m^3 . So the mean fill density based on these data is $44/1.54 = 28.6 \text{ kg/m}^3$. This assumes that the estimate of the number of bags of insulation used is correct and also that there was no loss of insulation to the sides of the cavity. A photograph of the technician filling the party wall cavity is shown in Figure 14.

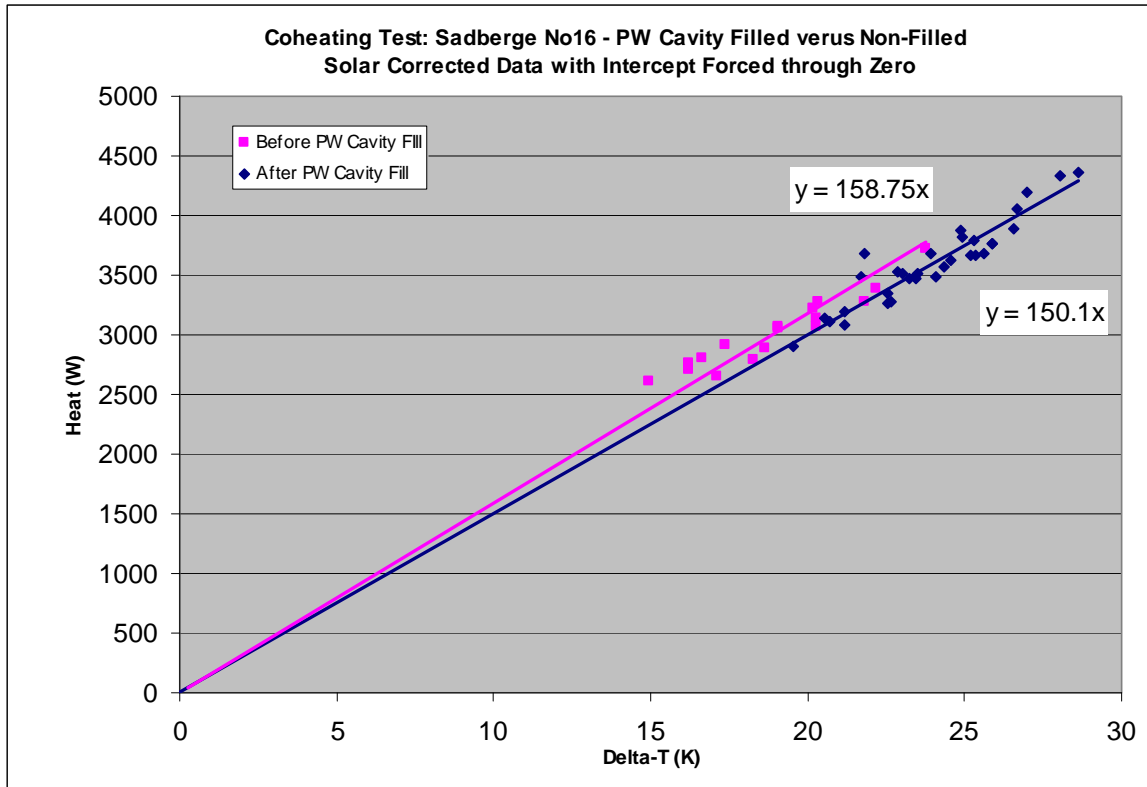
Figure 16 – Solar Corrected Heat Loss Curves before and after Filling Party Wall – House No.16

23 The results from the coeating tests in both test houses, before and after filling the party wall cavity are summarised in Table 13 (raw data) and Table 14 (solar corrected). The raw data show a reduction in the heat loss coefficient of between 5 to 8 W/K after filling the party wall cavity. The solar corrected data show a reduction in the whole house heat loss coefficient of around 9 to 10 W/K after filling the party wall cavity with insulation. Graphs showing the solar corrected heat loss curves both before and filling the party wall cavity are illustrated in Table 16 and Table 17.

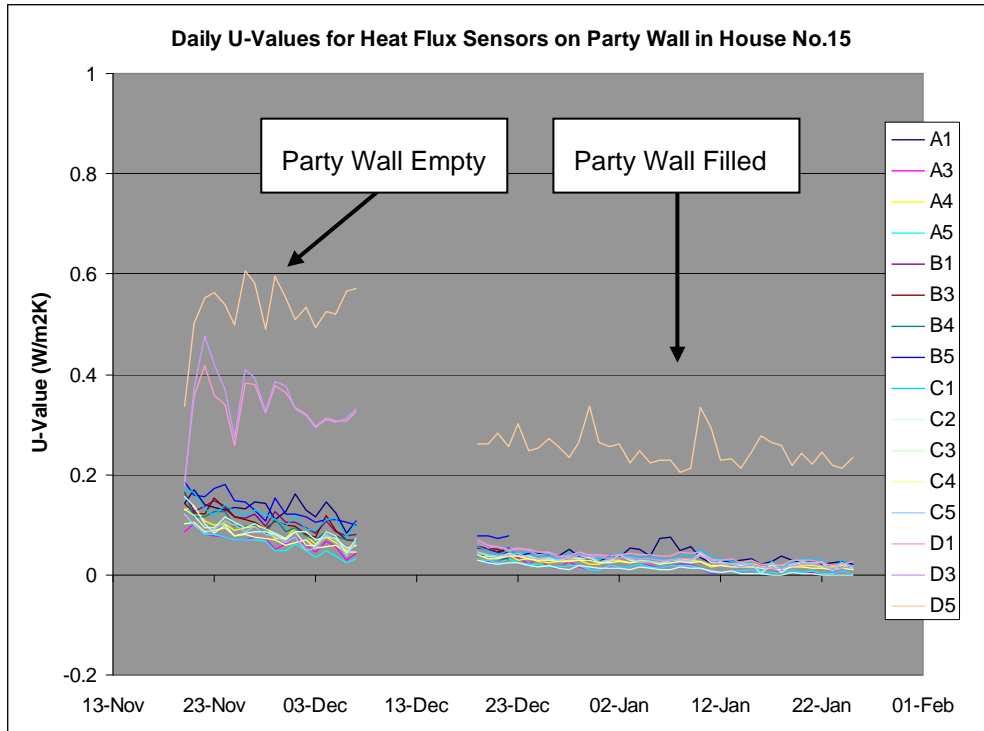
Figure 21 – Daily U-Values for Heat Flux Sensors on Party Wall in House No.15 (Access House)

30 Heat flux sensors (Hukseflux HFP-01) were affixed to various locations in the two dwellings. The majority of these were concentrated on the party wall in the Access House (No.15), with others on the party wall in No.16, the external walls in No.15, the ground floor in No.15, and the ceiling in No.15. The heat flux sensors on the party wall and external wall were positioned to avoid any hidden timber studs. Daily effective U-values for the sensors on the party walls were calculated from the heat flux readings and inside-outside temperature difference ($U\text{-Value} = \text{Mean Daily Flux}/\Delta T$). Graphs of the party wall U-value data are shown in Figure 21 and Figure 22. It can be seen from the graphs that the U-values at the sensor points before filling the party wall cavity range from around 0.1 to 0.7 W/m²K., with the majority of readings being towards the lower end of the range. As the heat flux sensors were deliberately located away from any timber studs in the panels, then this would indicate that, as would be expected, the insulated areas of the party wall do reduce heat loss via the party wall. The higher U-values are likely to be caused by the sensors being in proximity to timber studwork.

31 To account for the measured effective U-value for the whole party wall of ~0.4 to 0.5 W/m²K, it can therefore be concluded that the majority of heat flow into the party wall is occurring through the timber and at the edges of the cavity. There is also likely to be some contribution to party wall heat losses due to the step in the terrace between the two houses, and also due to the gap in the party wall in the loft. The percentage of area of the party wall comprising timber (studs, wall plates, sole plates and intermediate floor structure) rather than insulation was calculated from the timber panel drawings to be 17.4%.

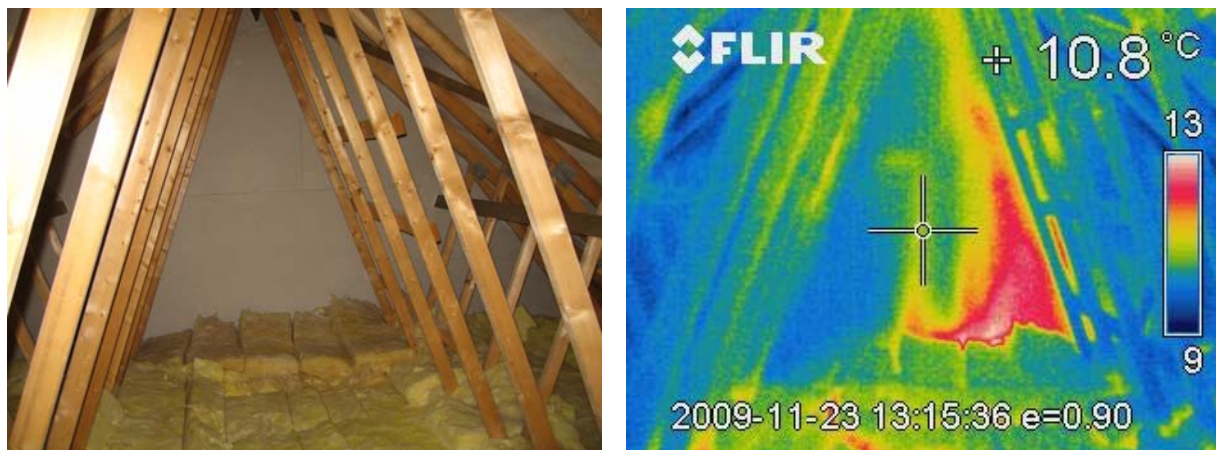
Figure 27 – Photograph and Thermal Image of Party Wall in Loft of House No.16

36 Thermal imaging of the test dwellings was carried out using either a FLIR Thermacam B4 or FLIR Thermacam B620. Observations were made over several days, both from inside and outside the dwellings, with range of external conditions (e.g. windy, sunny, and overcast). Very few significant thermal anomalies were found. Heat plumes were observed at the party wall in both lofts as

illustrated by the images shown in Figure 27 and Figure 28. These heat plumes are further evidence of a thermal bypass operating in the party wall cavity.

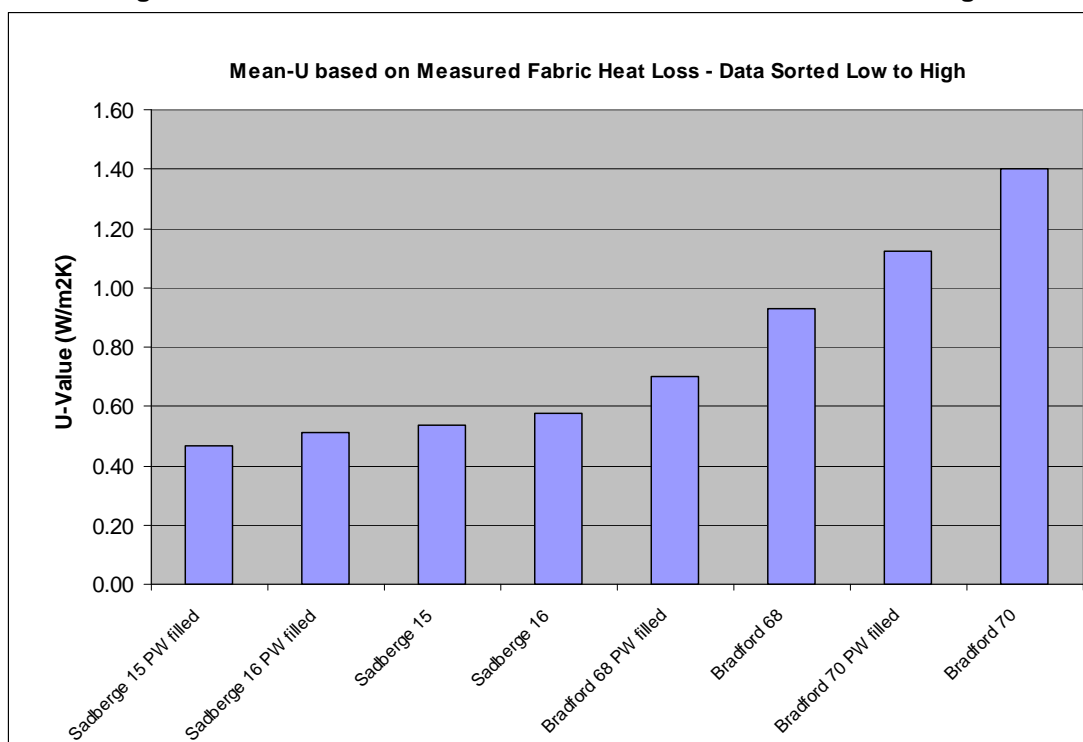
Figure 33 – Measured Mean Fabric U-values: Data Sorted Low to High

- 41 Another way to compare the performance of the test houses is to derive a mean U-value for fabric heat loss. This is calculated from the difference between the measured whole house heat loss coefficient and the ventilation heat loss (derived from air permeability) divided by the exposed area (excluding party walls). The advantage of comparing fabric U-values is that it excludes the effect of changes in ventilation loss due to the testing, and normalises the data. Fabric U-values are given in

Table 25 and also shown in Figure 33 with the data sorted from lowest to highest. The house with the lowest mean U-value (0.47 W/m²K) was Darlington No.15 after filling the party wall, compared to the highest U-value (1.4 W/m²K) for the mid terrace at Bradford.
