## Airtightness IS a construction issue

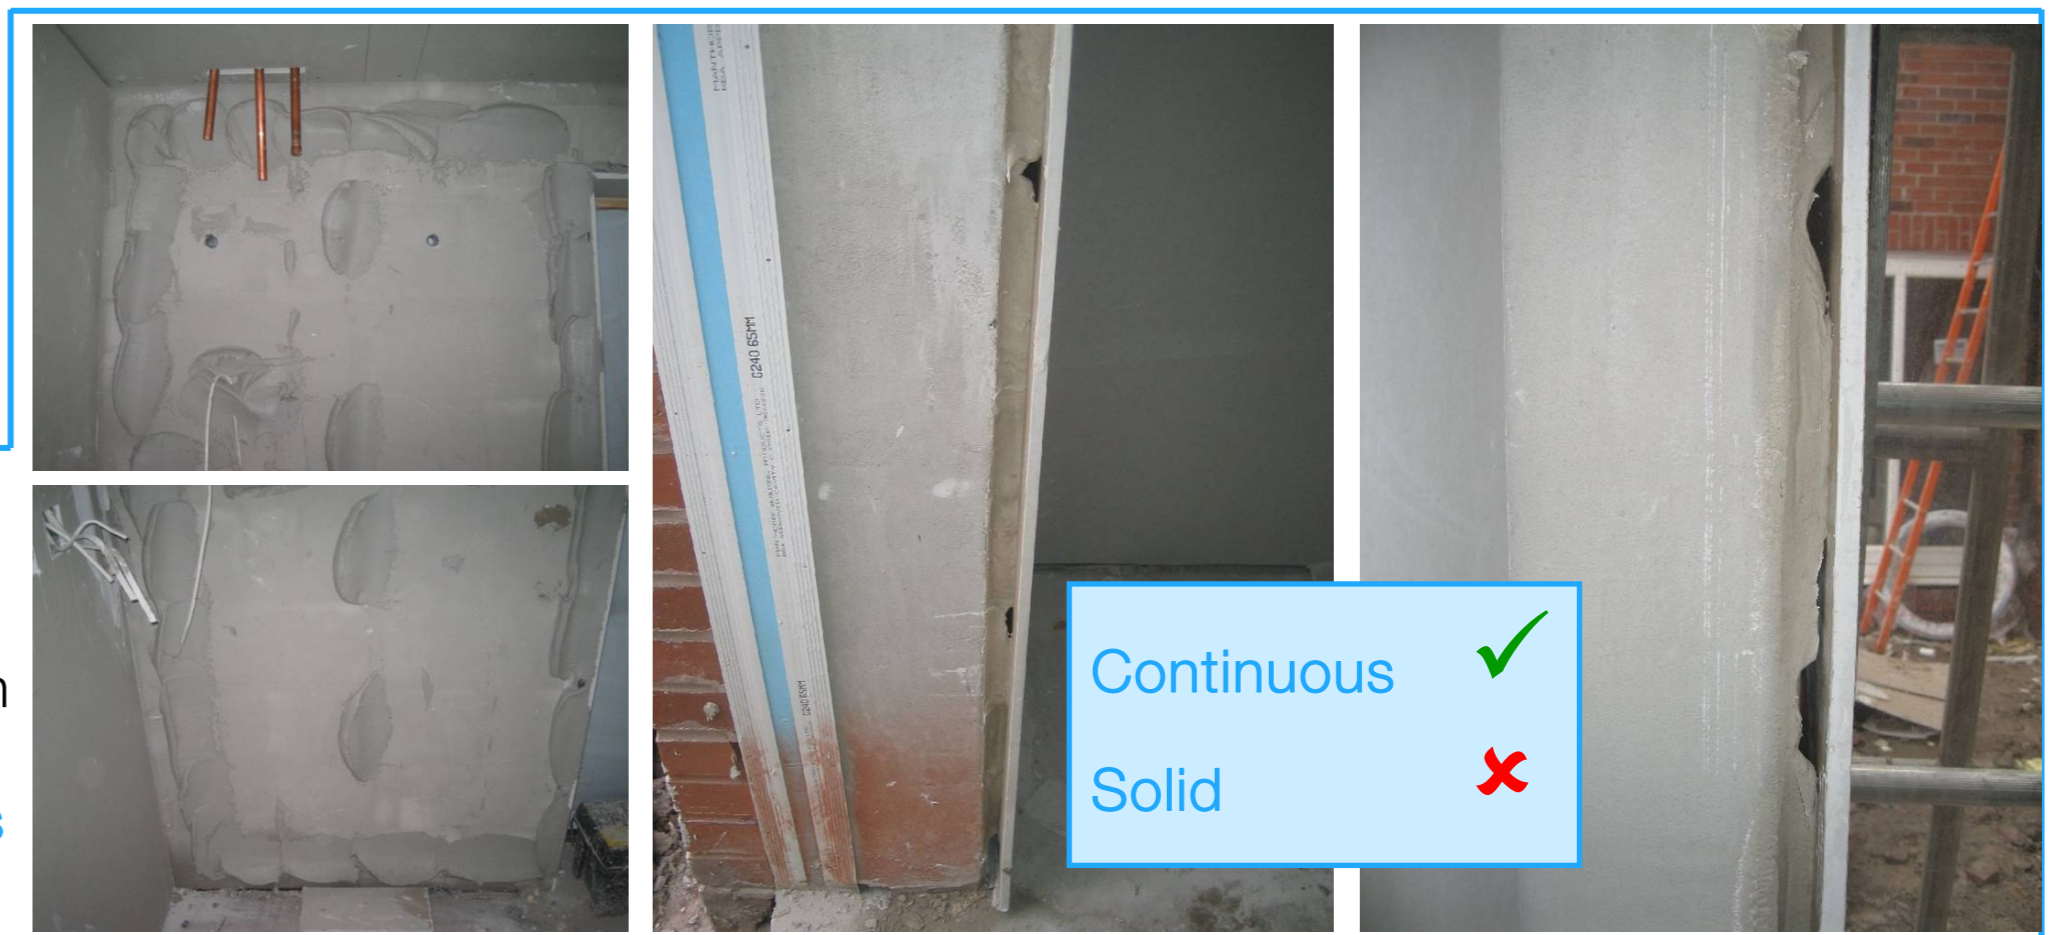
When you seal and inspect the air barrier can be as important as how you do it. In this example the electrical penetration (upper left) has been sealed at the 1<sup>st</sup> fix stage, with a suitable mastic, and looks airtight. However, somewhere between then and the 2<sup>nd</sup> fix (lower left) the sealant has become dislodged and not been replaced.

The thermal image of the detail (right), taken under depressurisation, illustrates the air leakage at this point, as well as showing cold air being drawn in from the loft around gaps in the "continuous" plasterboard dabs.

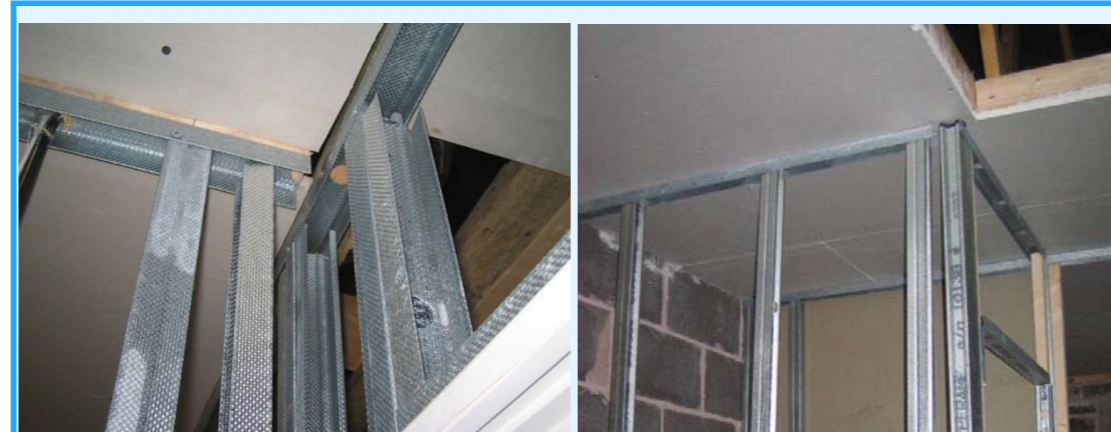
A change in sequence from partitioning-first to ceilings-first dramatically improved airtightness for Bryant Homes at Stamford Brook.

The build sequence adopted can present problems of accessibility when constructing the air barrier and maintaining its continuity. The lack of detailed planning of work sequences can lead to a completed detail being constructed then damaged for a subsequent installation, before being repaired. This "build – damage – install – repair" approach is both inefficient and unnecessary.
